## Stream Channel Protection, BMP 14.17

### Objectives

- 1) To protect stream channels by creating a temporary emergency overflow for spring flooding prior to culvert upgrading.

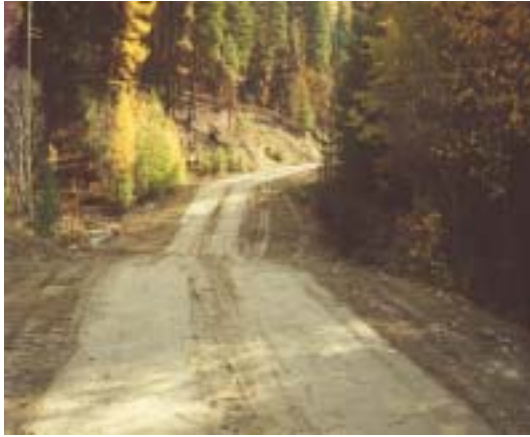
Photo 1 - Camp Creek before rock layers

The fills over the culverts were excavated to accommodate the calculated volume of a 100-year flood. A spillway was constructed at each crossing to let water pass safely over the road (photos 1 & 2). A layer of large rocks was placed along the bottom of each spillway, with a layer of smaller rocks on top. The rock layers armor the road, reducing the amount of sediment available (photos 3 & 4). The culvert inlets and outlets were rock armored (photos 5 & 6). Finally, slash-filter windrows were constructed at the culvert outlets to further filter sediment and to increase bank stability (photo 7).

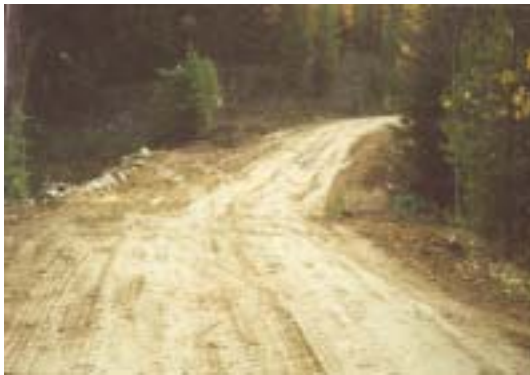
Photo 2 - Soldier Creek before rock layers

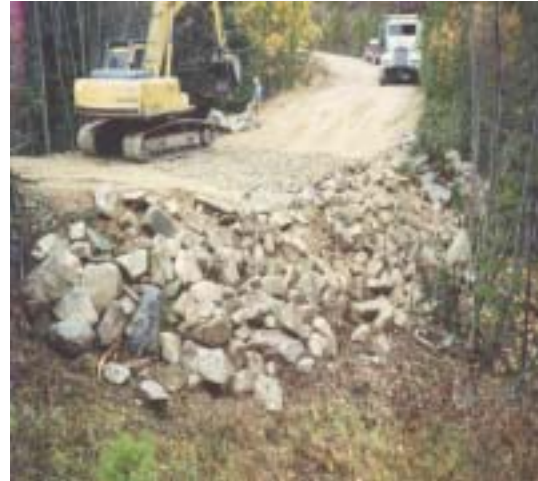
Photo 3 - Camp Creek rock layering

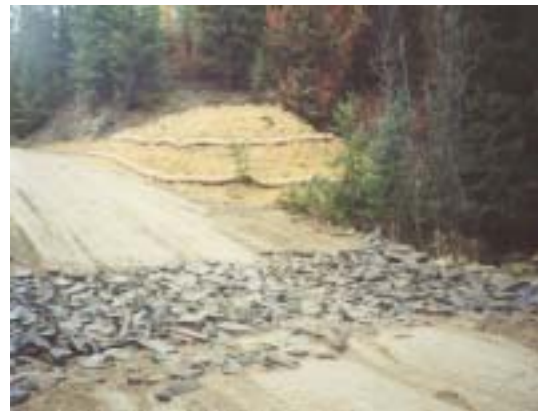
Photo 4 - Soldier Creek rock layering with straw wattles over grass seed and mulch, protecting the cutslope on the far side of crossing

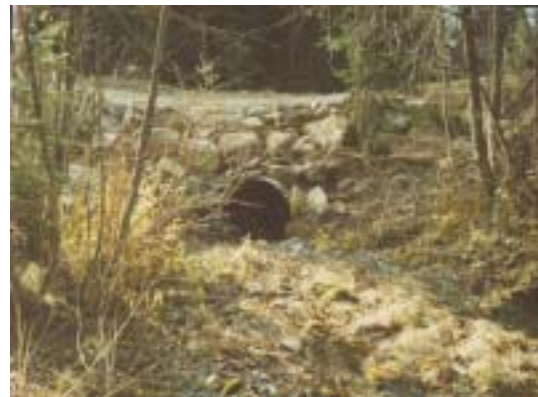
Rocks, 1 to 3 feet thick, were used to armor the inlet at Camp Creek and 1 to 2 feet thick at Soldier Creek. Rock armoring was securely placed, increasing bank stability and protecting the banks from erosion at both sites.

Photo 5 - Camp Creek's armored inlet

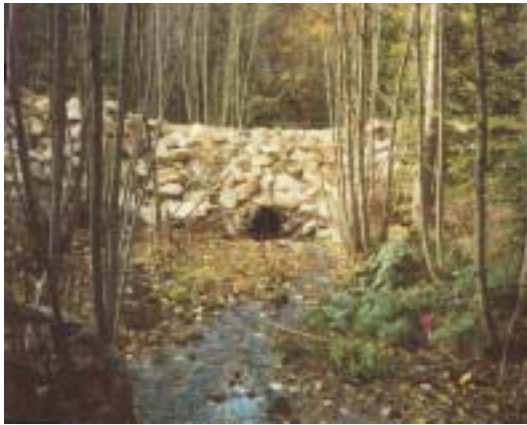
Photo 6 - Soldier Creek's armored inlet

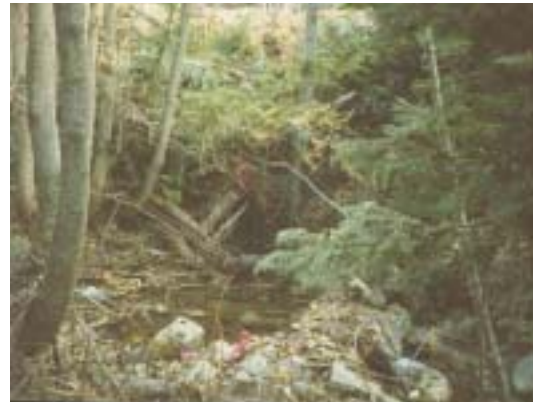
The slash-filter windrow over the outlet of Camp Creek was built of large branches.

Photo 7 - Camp Creek slash-filter windrow
